RISK

MODULE 3

BUILDING ENVIRONMENT 2

ASBESTOS

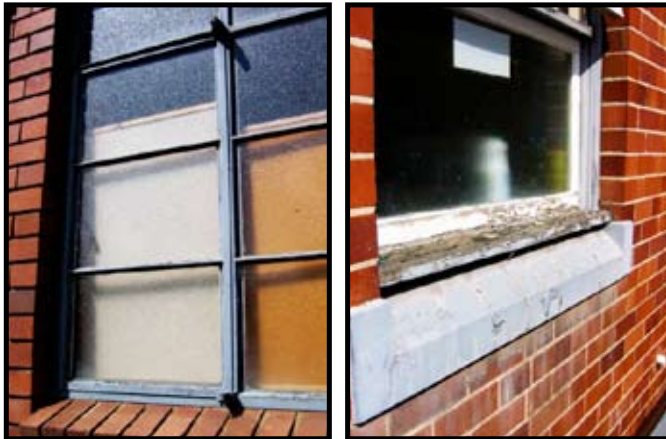
Lead in paint is a health risk as the paint can enter the body through contact and frequently with children through ingestion. If the paint is removed and not captured it can contaminate building surfaces, the soil and be carried off during rainfall into natural waterways where it accumulates as sediment. Examples of lead based paints that need removal are shown in these photographs.

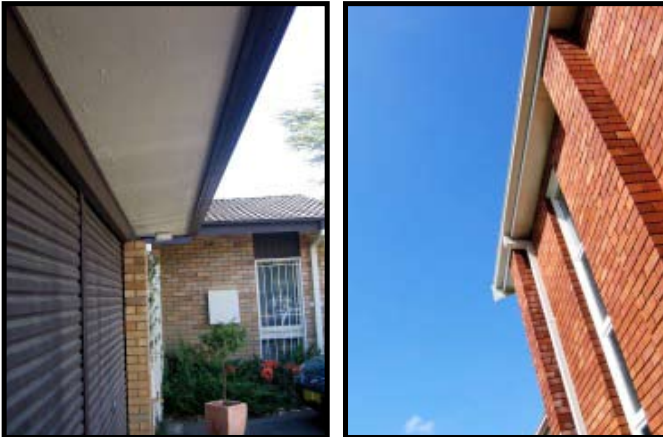
Asbestos cement surfaces can have the paint deteriorate and either bubbles form or the paint begins to flake. The repainting of the surface requires the damaged paint to be removed. Examples are shown below.

The danger in removing the damaged paint surface is in abrading/damaging the asbestos cement surface and causing the release of asbestos fibres. There is also the danger on buildings painted prior to 1976 that the paint may contain lead. If this is known or even suspected then refer also to Work Practice Guide No.3.

If the asbestos cement surface has the cement lifting and asbestos fibres are clearly visible then the cladding will need to be replaced and not repainted as the risk of releasing asbestos fibres is high.

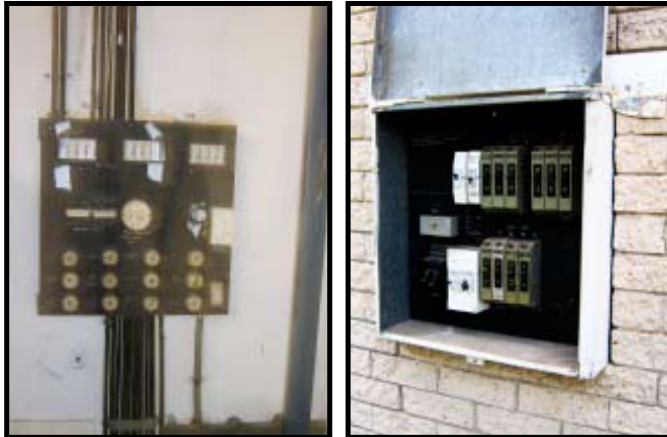
Electrical panels frequently have boards that contain asbestos fibres. Examples are provided below.

These boards need to have asbestos warning labels attached. This procedure assists in guiding your management of this issue.

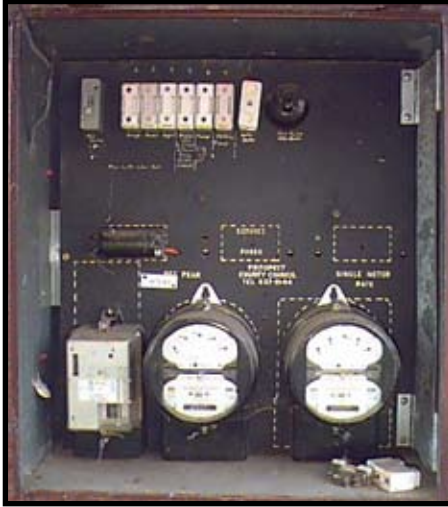
ANNEXURE 1

This photograph is an example of an asbestos-based electrical backing board in a typical domestic installation. Note the dust in the bottom of the cabinet and on the fittings. All dusts inside the cabinet are assumed to be contaminated with asbestos.

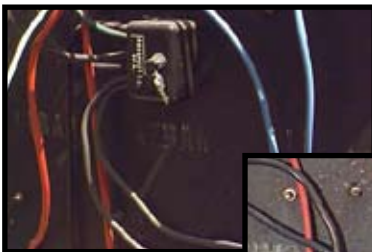
ANNEXURE 2

This photograph shows the “Lebah” stencilling on the rear face of the panel seen in Example 1. All panels labelled with “Lebah”, “Ausbestos”, “Zelminite”, or similar are assumed to contain asbestos.

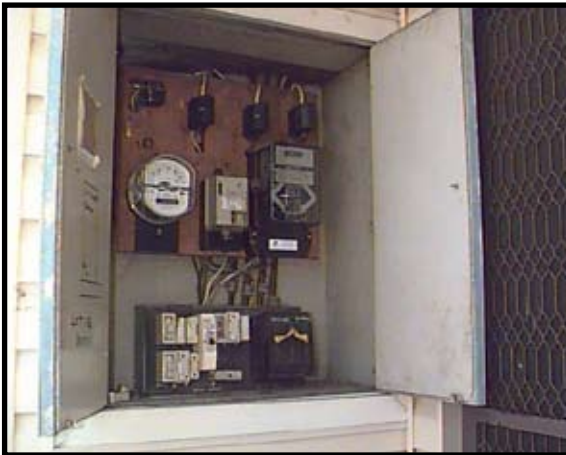
The bottom photograph shows a typical domestic meter box. Although the metering equipment is mounted onto a timber board, the internal faces of the cabinet are lined with asbestos millboard.
